SHAKING AND GROUND FAILURE-INDUCED DAMAGE TO BUILDINGS BY THE 2010 AND 2011 CHRISTCHURCH EARTHQUAKES AND ITS LESSONS

Ömer AYDAN
Ocean Research Institute
Tokai University, Shizuoka
Japan
e-mail: aydan@scc.tokai-u.jp

Reşat ULUSAY
Department of Geological Engineering
Hacettepe University, Ankara
Turkey
e-mail: resat@hacettepe.edu.tr

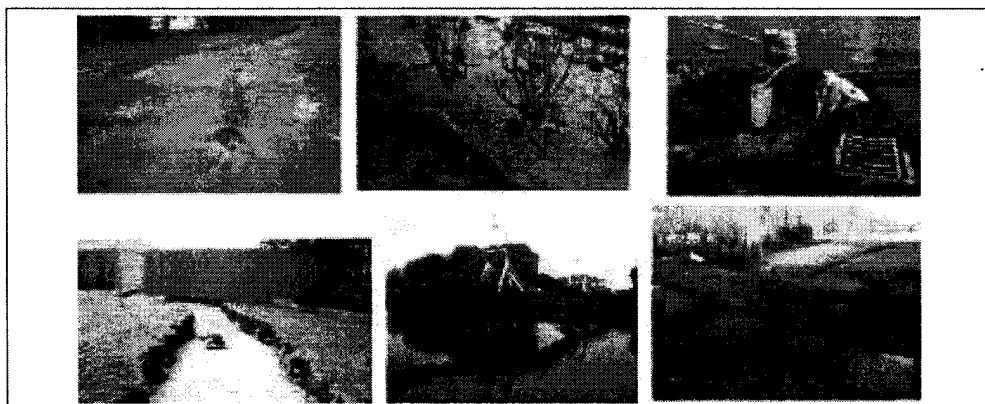
One of the major characteristics of the 2010 earthquake is the extensive ground liquefaction over a wide-spread area. Extensive ground liquefaction was observed in the eastern suburbs of Avonside, and Shirley, and in Kaiapoi, Brooklands and the new suburb of Bexley (Figure 3). Due to the liquefaction induced ground settlement and lateral spreading, residential buildings and lifelines on liquefied ground suffered extensive damage. The effect of lateral spreading of liquefied ground was damaging even to reinforced concrete structures such as Canterbury Rowing Club Building and Sport Facilities in Porrit Park. Light structures were uplifted while heavy structures sank into the ground. The ground liquefaction also caused extensive damage to bridges. Furthermore, the lateral spreading induced failures of embankments and tidal gates. It is reported that ground liquefaction risk at the Pegasus Town site was identified in 2005 and the ground was remediated. These counter measures proved to be effective in Pegasus town and liquefaction was not reported there. The bridge on Bridge Street connecting South Brighton to Christchurch, suffered damage due to the settlement and rotation its abutments, as well as extensive cracking and settlement of the approach abutments due to ground liquefaction.

Figure 3 : Views of ground liquefaction at some localities caused by the 2010 earthquake.

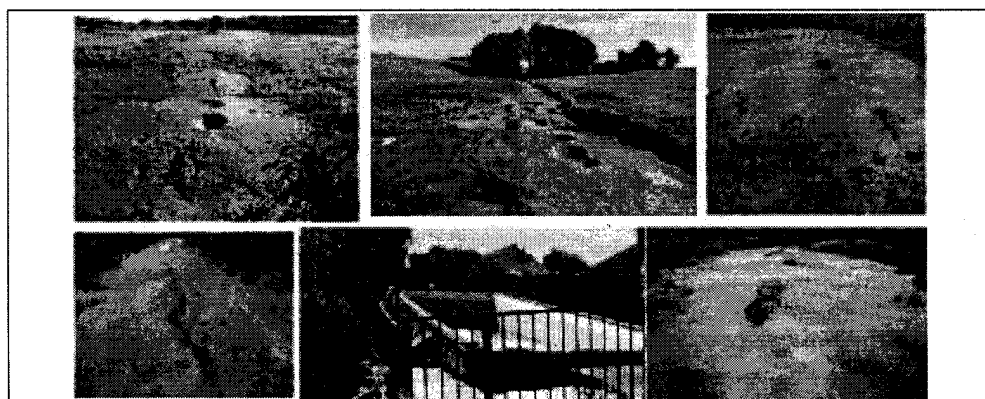
The 2011 earthquake caused more extensive ground liquefaction and associated lateral spreading in Christchurch City central business district, areas such as Mona Vale, Hagley Park, Heathcote, Opawa, Woolston, Ferry Mead, McCormacks Bay and Tai Tapu, in addition to Avonside, and Shirley, and in Kaiapoi, Brooklands and the new suburb of Bexley areas which liquefied in the 2010 Darfield earthquake (Figure 4). The lateral spreading along the Avon River was much more severe in the 2011 earthquake and the ground settlement was more extensive in Bexley. Although there was widespread liquefaction in Kaiapoi town, the effects of ground liquefaction and lateral spreading were much less than those caused by the 2010 earthquake. Residential buildings and lifelines on liquefied ground suffered extensive damage. The bridge on Bridge Street connecting South Brighton to Christchurch suffered more damage due to settlement and rotation of its abutments, as well as the extensive cracking and settlement of approach abutments due to ground liquefaction.

Figure 4 : Views of ground liquefaction at some localities caused by the 2011 earthquake.

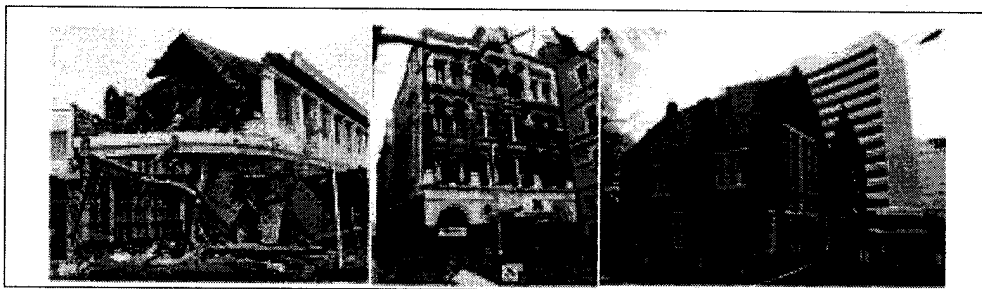
Many of the worst-affected buildings in both Christchurch and the surrounding districts by the 2010 Darfield earthquake were older unreinforced masonry buildings (Figure 5). The low story timber framed residential houses, except those on liquefied ground and new reinforced concrete or steel framed buildings, were almost intact. These buildings are characterized as typically 2- or 3-stories. However, 2- story buildings are most common. The causes of damage to unreinforced masonry buildings may be classified as (a) out-of-plane failure of walls, (b) parapet failures, (c) anchorage failures and (d) Chimney failures. It is estimated that 500 such buildings were damaged. 90 buildings in Christchurch Business District (CBD) were damaged. Some of retrofitted masonry buildings in the downtown of Christchurch performed well and there was almost no damage to such retrofitted masonry buildings. Nonstructural damage was due to partitions cracking, fall or toppling of ceiling tiles and lights in all types of buildings. Furthermore, glasses of windows with large span were broken.

Figure 5 : Views of some of damaged masonry buildings.

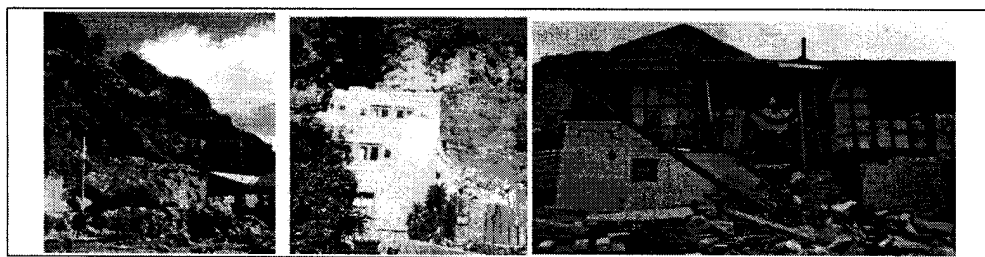
Figure 7 : Views of damage to buildings caused by rockfalls.

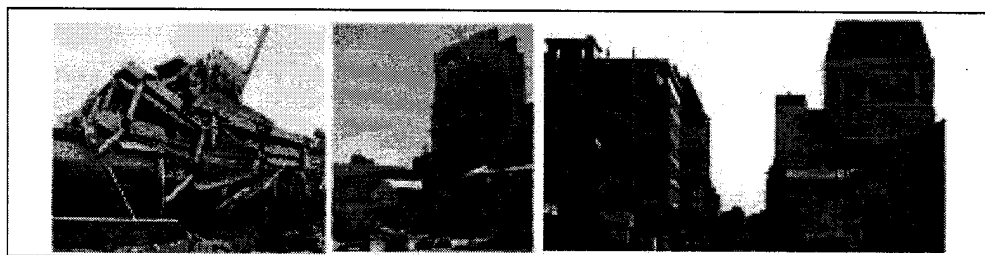
Figure 8 : Views of damage to reinforced concrete buildings in Christchurch.

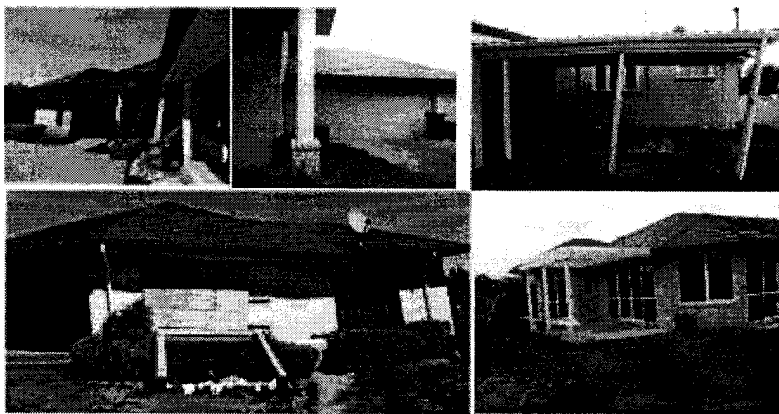
Ground liquefaction caused by the 2010 Darfield earthquake resulted in heavy damage to residential buildings in Kaiapoi and Bexley areas along Avon River in Dallington district (Figures 9 and 10). The lateral spreading caused damage to buildings. The details of ground liquefaction by two earthquakes are given elsewhere [1-3].

Figure 9 : Views of ground liquefaction observed at several localities during the 2010 Darfield earthquake.

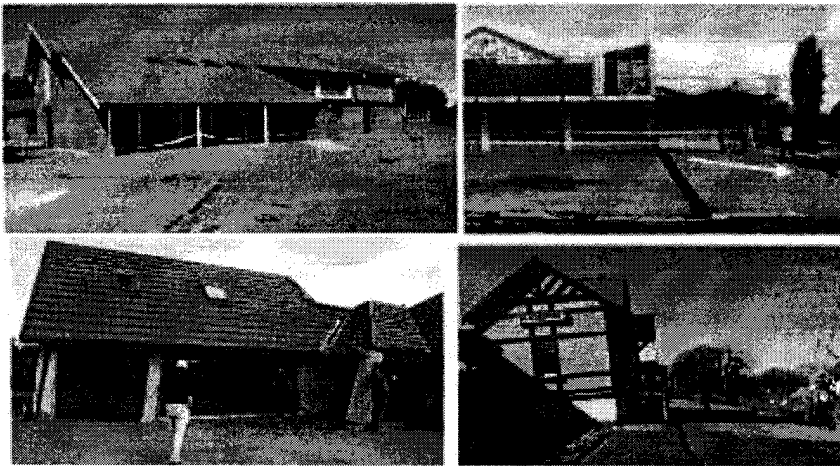
Figure 10 : Views of damage to buildings caused by ground liquefaction during the 2010 earthquake.

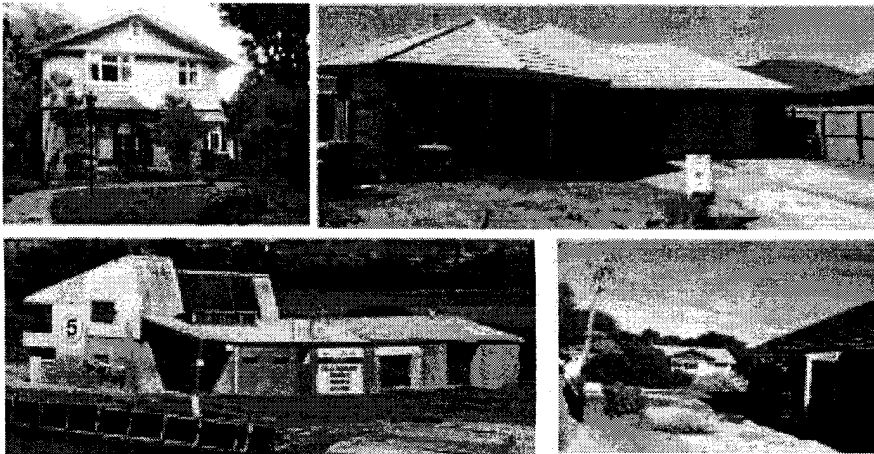
Ground liquefaction caused by the 2011 earthquake occurred in the most-vulnerable areas along Avon River and Heathcote valley as predicted by the hazard map of the Christchurch City Council (Figure 1). The effect of ground liquefaction in Christchurch was much heavier than that caused by the 2010 Darfield earthquake. (Figures 11 and 12). The lateral spreading caused damage to buildings. Furthermore, the ground liquefaction in downtown of Christchurch caused tilting of some high-rise buildings and played major role in the collapse of two reinforced concrete buildings.

Figure 11 : Views of ground liquefaction observed at several localities during the 2011 earthquake

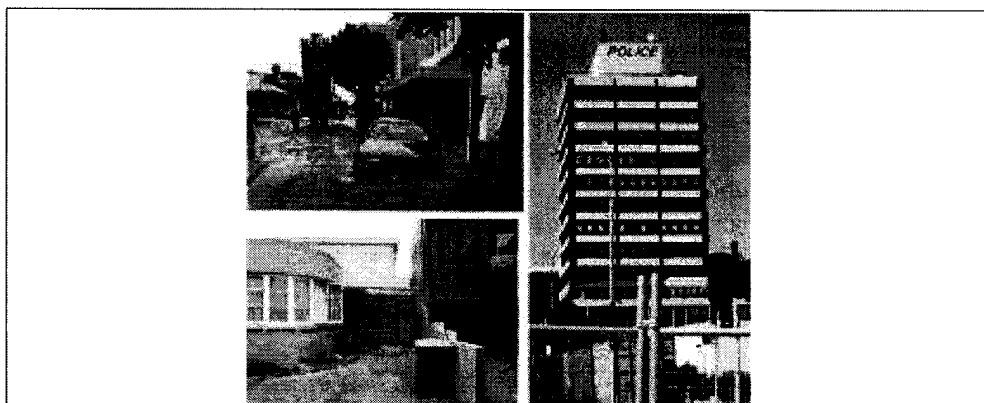
Figure 12 : Views of ground liquefaction observed at several localities during 2011 earthquake.
