EXPERIMENTAL STUDY OF HYGROTHERMAL PERFORMANCE

A.S. Guimarães, V. Abrantes, T. Silva
Faculty of Engineering
University of Porto (FEUP)
Portugal

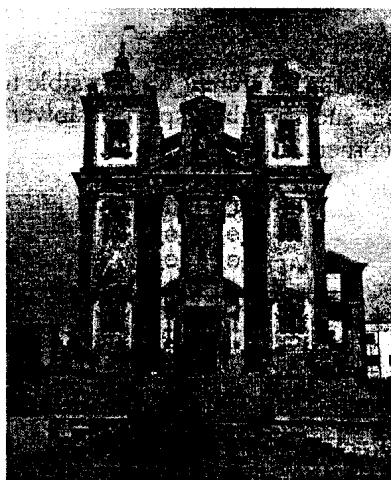
Figure 1 : Santo Ildefonso Church (main façade)

This church was built as from 1709 over the foundations of Santo Ildefonso Chapel that was in ruins, staying concluded at 18 July of 1739. It's firm a platform on top of a big staircase. Its façade is regular, formed by two bells towers, finished by spheres and fantastic facades in each surface. The granite walls are thick, being the façade covered with glazed tiles by Jorge Colaço (1932), portraying Santo Ildefonso living scenes and allegories to holy communion. Inside, the plant is polygonal in proto-baroque style with a vault roof of wood and adornment plasters repeated in walls. It has also six altar niches and two pulpits, being the floor made of wood. The high chapel (Figure 2) exhibit the panel of golden cut decorated with plaster Works, incorporating a vault roof with two sides and a central lantern.

The building analyzed in this work was the Santo Ildefonso, which is at one extremity of Battle Square in Porto (Figure 1).

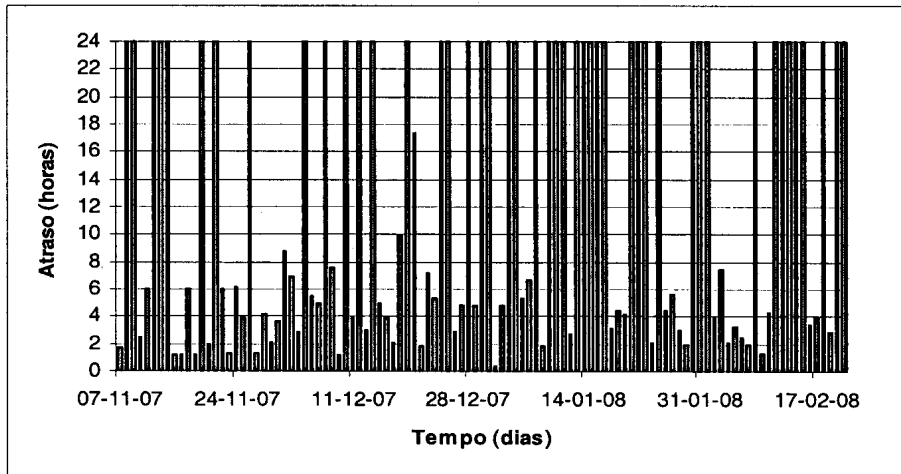
This behaviour shows with clarity the effects of walls thermal inertia that amortize the temperature's peaks, keeping a constant and comfortable atmosphere inside the church. It was also visible that the incensement of exterior's temperatures by turn of February, which led to higher thermal amplitudes on the outside, didn't make it felt inside the building. Thermal delay, in several days, was so exalted that not even affected interior's temperatures, in those same days. This means that, in these cases, the temperature inside the church didn't suffer any increase, despite the rise of temperature on the outside. Once again we confirm the thermal inertia's effect that delays the heat transmission through its accumulation inside the constructive elements (Figure 9).

Figure 9 : Daily rate thermal delay between the beginning of day 07/11/2007 and the end of day 21/02/2008
