## **EXPERIMENTAL DIAGNOSIS OF EARTHEN CONSTRUCTION: CHARACTERIZATION AND IN-SITU ESTIMATION**

I. Lombillo and L. Villegas  
R&D Group in Building Technology (GTED-UC)  
University of Cantabria, Spain.  
e-mail: ignacio.lombillo@unican.es

### **ABSTRACT**

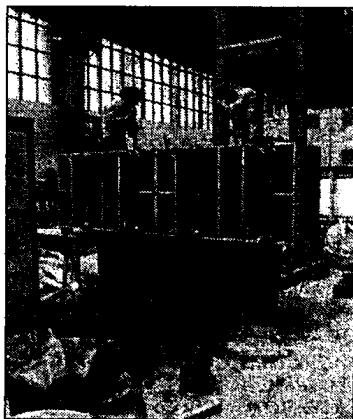
**FIG 12.** Progressive dumping of earth and its compaction by ramming.

**FIG 13.** Progressive dumping of earth and its compaction by ramming.

**FIG 14.** Progressive dumping of earth and its compaction by ramming.

FIG 12 to 14 illustrates the process of construction of the rammed earth wall (Lombillo 2010). Several compression tests were performed on cylindrical samples made with the same earth used in the construction of the wall. The following data were obtained: stress-strain curve, compressive strength and strain in fracture. FIG 15 and 16 illustrate one of the tests, as well as the stress-strain curve obtained. The results are summarized on TABLE 3.
