RETROFITTING STRATEGY TOOL FOR TIMBER FLOOR STRUCTURES

J.A.R. Mendes da Silva, M. Nobre
Department of Civil Engineering
University of Coimbra
Portugal

R. Vicente
Department of Civil Engineering
University of Aveiro
Portugal

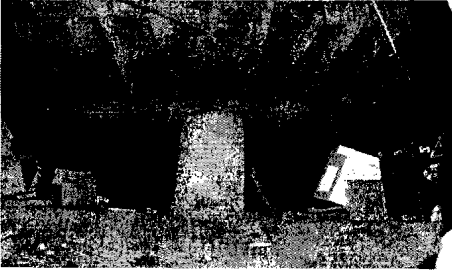
<p>a)</p>

<p>The floor is located in an earthen platform, and presents an air gap of about 0.9 m.</p> <p>The timbering is constituted of beams arranged parallel to each other, recessed in walls which are supported by structural beams, intermediate, and perpendicular.</p>
<p>b)</p>

Figure 2 : Structure and details of the elevated timber floor

This case study corresponds to the structure of a dining room floor, in which the timbering is accessible through an access at ground floor level. Between the inferior face and the earth surface exists an air gap. A technical inspection was carried out and the structure of the framework under consideration does not manifest any signs of biological attack, nor does the present any deformations. It was not also affected by the rainwater, and in particular, rising damp. The ventilation of the air gap has contributed to maintain the good condition. There were no signs of biological agents, eventually because the environmental conditions are not favorable to their presence (humidity and temperature).
